Date of Inspection: 11/15/2007

Visual Home Inspection Report

101 Main Street, Eureka, CA

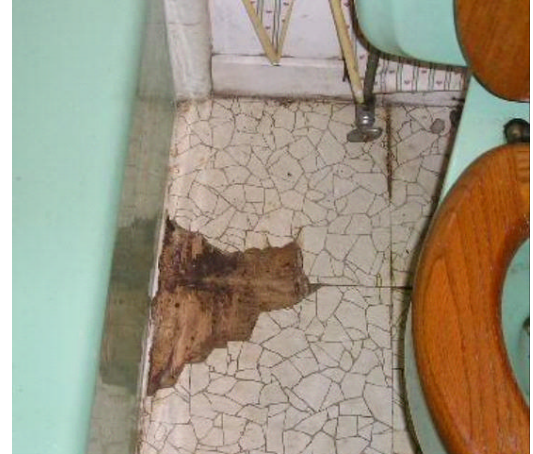
ACTION ITEM: Staining/discoloration and deterioration was noted near the toilet, which is likely due to moisture intrusion. Recommend further evaluation and repair as required by a qualified tradesperson.

Bathroom floor damage
