Safety Glazing, by Douglas Hansen

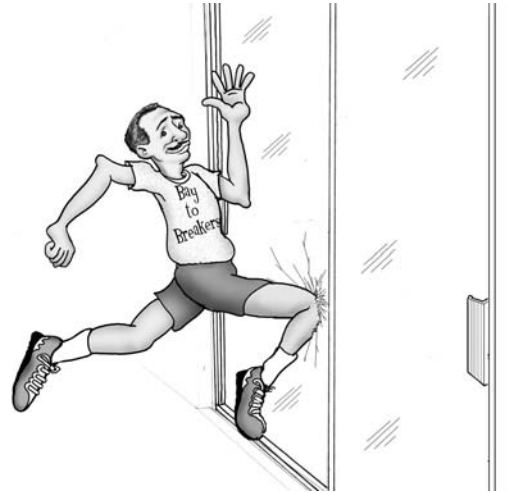
Figure 1 – Accidental Impact with Glass

The rules in building codes and federal standards typically are based on one or more of these factors. Historically, the greatest number of injury accidents has been from shower doors or patio doors (figure 1).

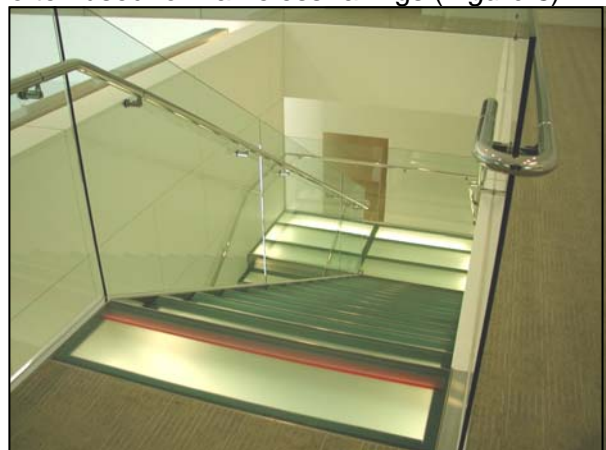
Figure 3 – Laminated Glass Railing

Laminated glass has two separate pieces of annealed, heat-strengthened, or tempered glass sandwiched around a layer of clear polyvinyl butaryl (PVB). The layers are bonded under high pressure. In the United States, it is used in car windshields. It is a safety glass product. One side can shatter from impact without the other side shattering, and when the glass shatters it does not delaminate into shards. Laminated glass is often used for frameless railings (*Figure 3*).

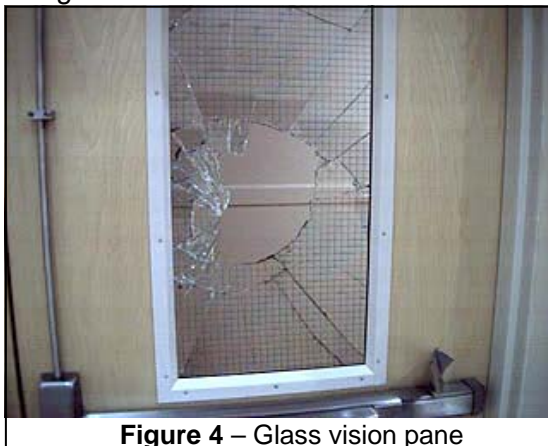
Figure 4 – Glass vision pane

Greg Abel, from the Advocates for Safe Glass, came to this issue in a personal way. His son was injured by a wired glass lite at his school basketball court (see *Figure 4*). The result was an injury that included severed nerves and tendons and permanent damage. Sadly, this story is not unusual; approximately 2,500 such injuries occur each year in elementary schools alone. Mr. Abel founded a nonprofit organization to raise awareness of this issue and to lobby for enforcement of requirements for impact resistance. Why did we allow glass that does not meet impact resistance standards in doors and other public areas? A long protracted lawsuit from the wired glass manufacturers (all based offshore) tied up the CPSC and resulted in exceptions that remained in the building codes until 2006.

Just because a piece of wired glass has a “bug” on it, do not assume it is safety glass. The vision pane in *Figure 4* is obviously in a location subject to human impact, but the “bug” stated that the glass was evaluated by UL only for fire-resistance, and not to any other standard.

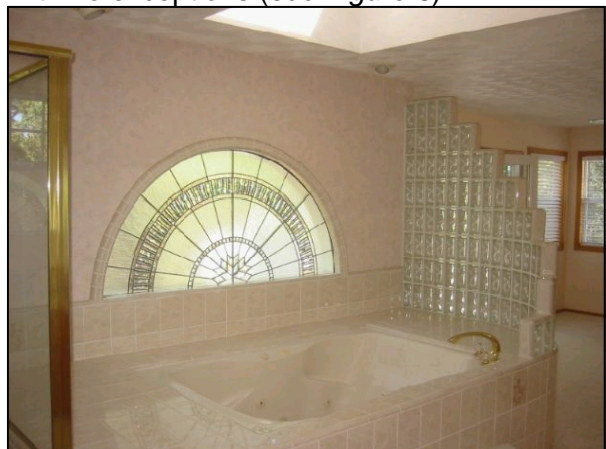
Figure 6 – Shower and Tub Enclosures
In this example, the shower enclosure at the left contained tempered safety glass, and the glass blocks at the end of the tub are exempt. The leaded glass next to the tub is not allowed; any windows in that area must be safety glass.

1. Swinging doors. Any glass pane in a door is required to be safety glass, with exceptions for jalousie windows, lites so small that a 3-inch sphere cannot pass through them (see Figure 5), and for art glass (etched, decorative, or beveled glass).
2. Sliding doors, including the fixed panes, and bifold closet doors, with no exceptions.
3. All glazing in storm doors.
4. Glazing in unframed swinging doors (these will typically be laminated glass).
5. Glazing in doors and enclosures for showers, tubs, saunas, and whirlpools, as well as windows in a wall enclosing such an area if the bottom edge of the window is less than 60 inches above a standing surface, with no exceptions (see Figure 6).

Jalousie windows are exempt. Their edges must be smooth, and they must be at least 3/16 inches thick. Finally, there is an overall exemption for glass blocks (figure 6) when they are properly installed in accordance with the rules for that form of masonry.

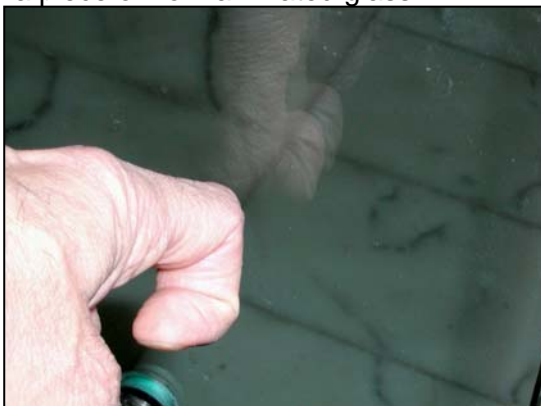
Figure 8 – Identifying Laminated Glass

Laminated glass is sometimes labeled, though most codes do not require it. Laminated glass can be identified by its reflection — if you hold your hand to it, you will see multiple reflections (see Figure 8). With a little practice, these are readily distinguishable from the two reflections you might see from the inner and outer surfaces of a piece of non-laminated glass.

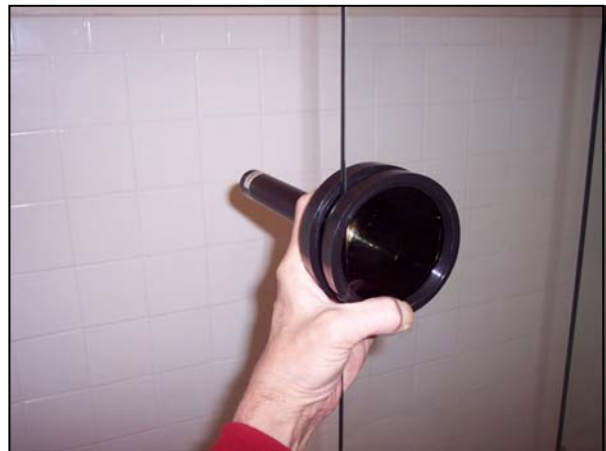
Figure 9 – Testing with polarized light lenses

Inspectors are often baffled by glass that has a frame obscuring the label, or in the case of shower doors, a soap or hardwater residue obscuring the glass. It is possible to verify that tempered glass is present by using a pair of polarized light lenses. Normally, if you hold two such lenses over your flashlight, and rotate the lenses to where their polarities are at 90 degrees to each other, all light will be blocked. If you do this with a pane of tempered glass between them, distinctive black lines will appear as you rotate the lenses toward total blackness (see Figure 9).

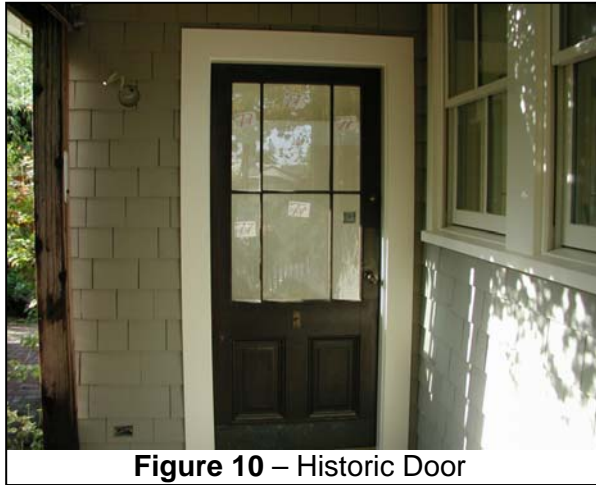
Figure 10 – Historic Door

Many owners and architects find the identifying bugs to be unsightly. Once in a while, building departments will allow omission on multi-lite doors. Such installations might be for a historical building (see Figures 10 & 11), where a door had custom-made pieces of tempered glass installed without a bug on them. Though the building code sections on glazing have no provision for omitting the bug, building departments can allow it through the administrative provisions for “Alternate Materials and Methods.” In such cases, there must be written documentation on file with the building department.

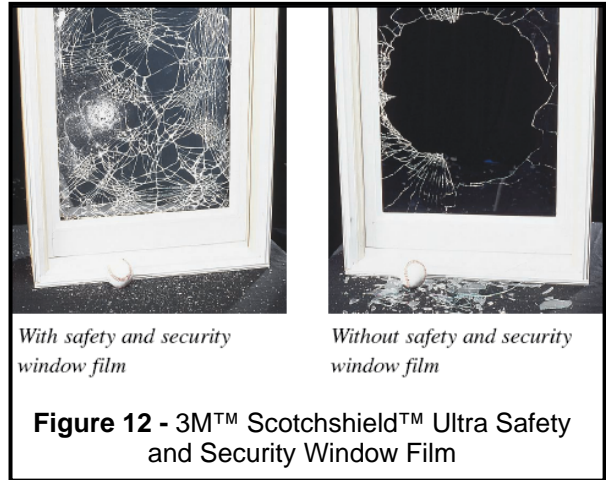
Figure 12 - 3M™ Scotchshield™ Ultra Safety and Security Window Film

Thousands of houses built in the 50s through the 70s have large floor-to-ceiling windows of ordinary glass, or have patio doors that are not safety glass. In lieu of replacement, it is possible to strengthen these doors and windows with products such as safety film products such as “Scotchshield” from 3M (figure 12). Applied properly, the material is durable, effective, and not noticeable when properly installed. Since it is a field-applied product, it does not meet the CPSC standard, though it does satisfy the requirements of jurisdictions such as Los Angeles. Inspectors can generally tell if the film has been applied because there will be a slight gap at the edges of the glass.
